FINAL REPORT ON LEAKY TOILETS PROJECT

AR 1053

Report title: Final Report for Leaky Toilets projects

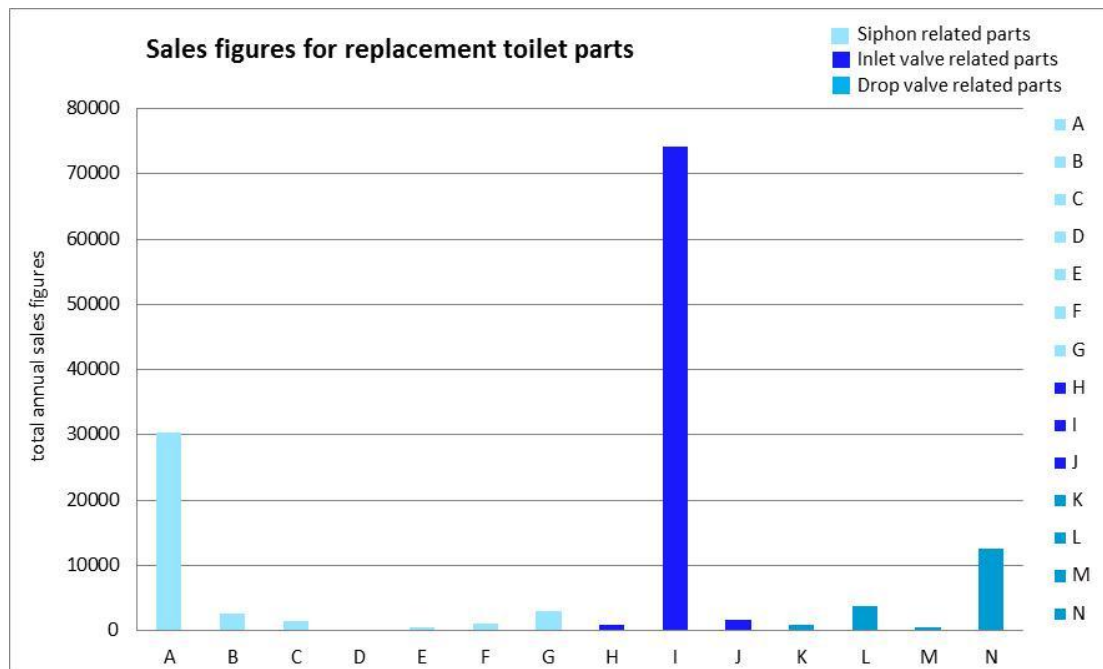
Figure 1 Sales Figures for replacement toilet parts in 2010

Figure 1 shows that a significant number of siphons have been fitted. The product in this data is a dual flush toilet which is retrofitted onto siphon cisterns to convert the single flush into a dual flush. The large volume of these being installed is positive as it suggests that more toilets are being converted into dual flush for the purpose of water saving. It may also indicate that some siphons and drop valves are being replaced with the retrofit products. The data also shows that there are a substantial number of dual flush drop valve buttons being replaced. The reason for this is unknown, but could be replacements due to failing devices.

The largest replacement part is related to the inlet valves, indicating that these could be a significant cause of water wastage from WC cisterns. This interpretation is very subjective but it has been included because but as the company holds a **quarter of the market share** and the trends may be transferrable to an understanding of a national picture.

The plumbers' merchant suggested that the sales figures regarding replacement parts from 'high street' retailers rather than the stockists would give a better picture (as a more popular choice for householders) but as stated they were unable to provide any information. Despite this, the data is worth including and is shown in Figure 1.

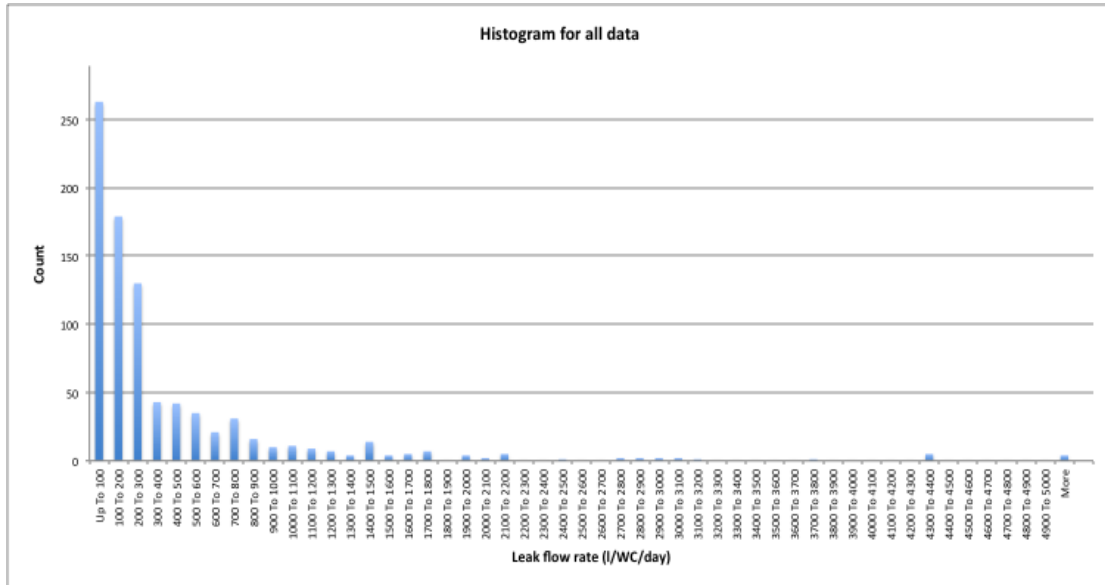
Figure 3 Histogram for all data

The dataset is skewed, as can be seen in the histogram in Figure 3, however as discussed in section 4.2, the data collected from bill queries is likely to be an underestimate, therefore it is suggested using the mean as the figure to be claimed for the water efficiency targets when a leaking WC is identified and repaired.

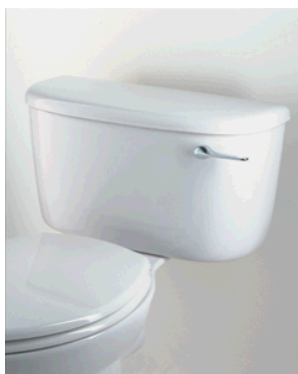
Traditional siphon with handle flush

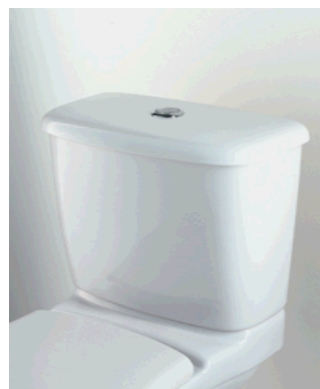
Drop valve – either one button or two (dual flush) buttons on front or the top
